# HURRICANE KATE STORM SURGE DATA

## Report 5

Andrew W. Garcia, William S. Hegge

Coastal Engineering Research Center

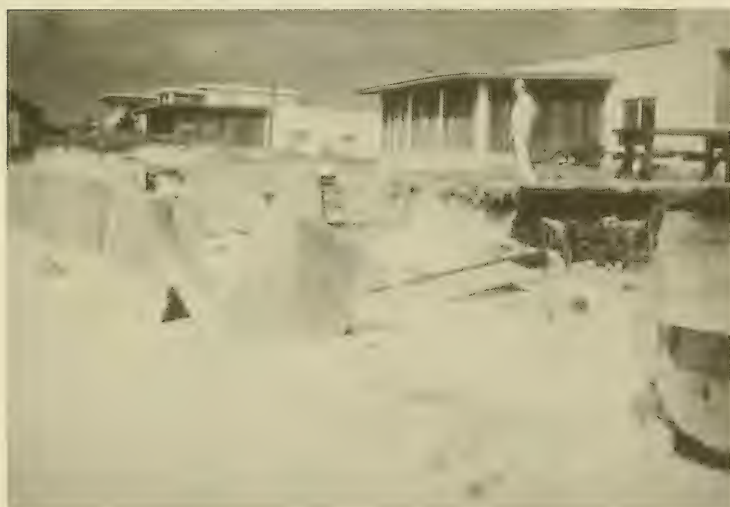
14. At Mexico Beach, the erosion was more severe, uncovering and destroying a seawall (Photo 2) that had been completely buried by a sand dune prior to the hurricane. Surge elevations estimated at this location from the watermark on the side of the canal on the west end of town (Photo 3) were approximately 7 ft. Wind damage in this area was relatively minor.

Photo 2. Destroyed seawall, Mexico Beach, Fla.

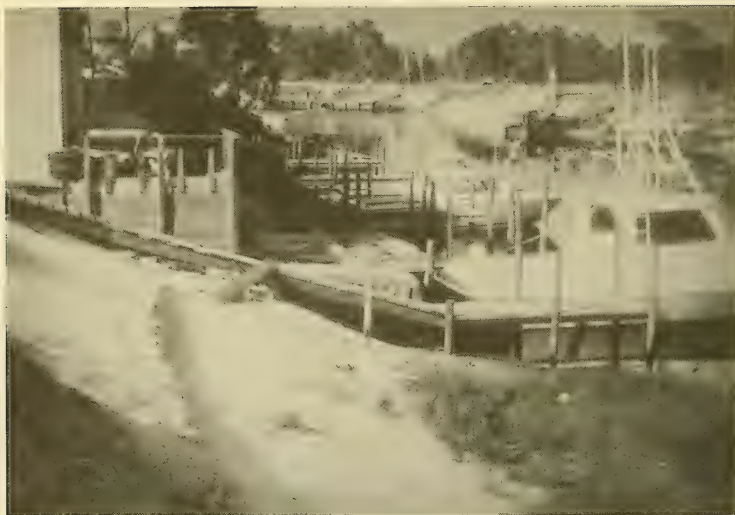
Photo 3. High-water mark, Mexico Beach, Fla.

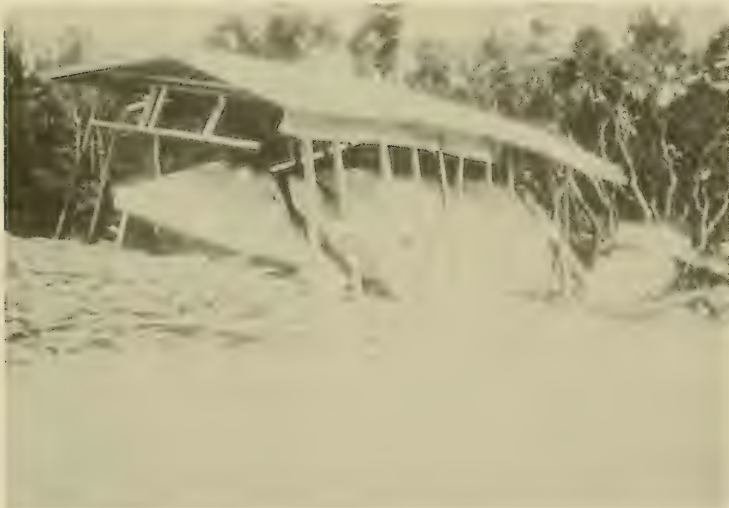
Photo 14. Trailer destruction between East Point and Carrabelle, Fla.

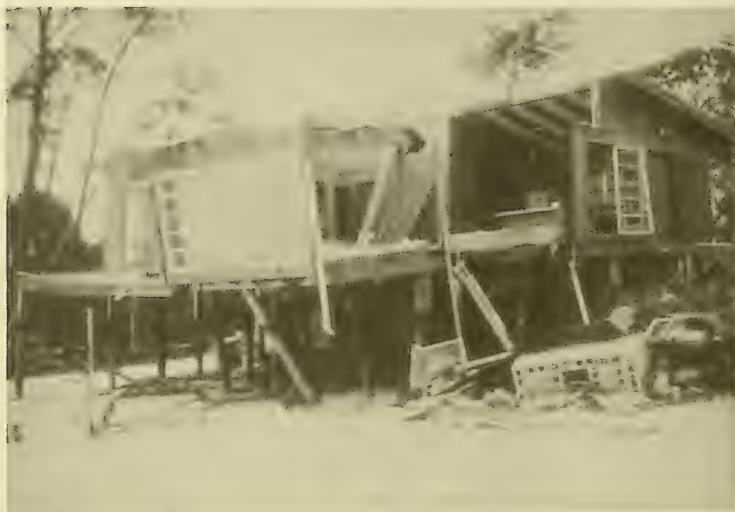
Photo 15. House destruction between East Point and Carrabelle, Fla.

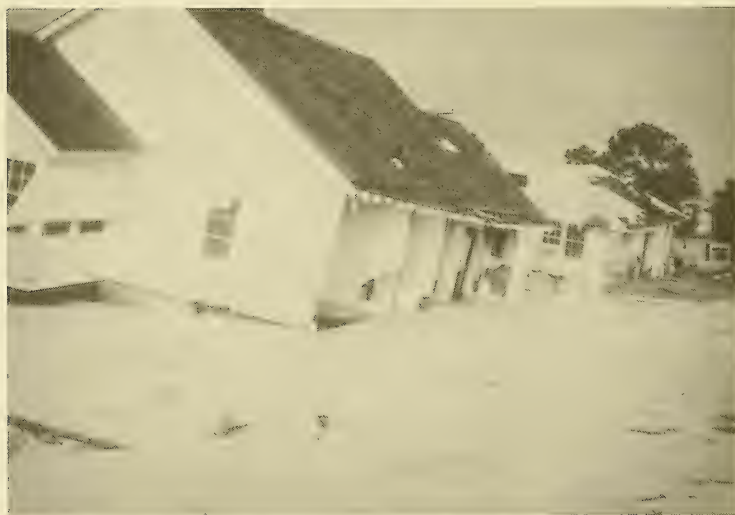
Photo 16. House destruction, Lighthouse Point, Fla.
